**BUILDING-STRUCTURE INVENTORY FORM**

- 1. BUILDING NAME(S): Nolte House
- 2. COUNTY: Monroe TOWN/CITY: Greece VILLAGE: ---
- 3. STREET LOCATION: 151 Dorsey Road (just west of Tait Ave.)
- 4. OWNERSHIP: a. public  b. private
- 5. PRESENT OWNER: Francine Cruikshank ADDRESS: (same) Rochester, NY 14616
- 6. USE: Original: residence Present: residence
- 7. ACCESSIBILITY TO PUBLIC: Exterior visible from public road: Yes  No   
Interior accessible: Explain private residence

Town of Greece Historic Sites Survey  
Monroe County, New York  
151 Dorsey Road  
page 5

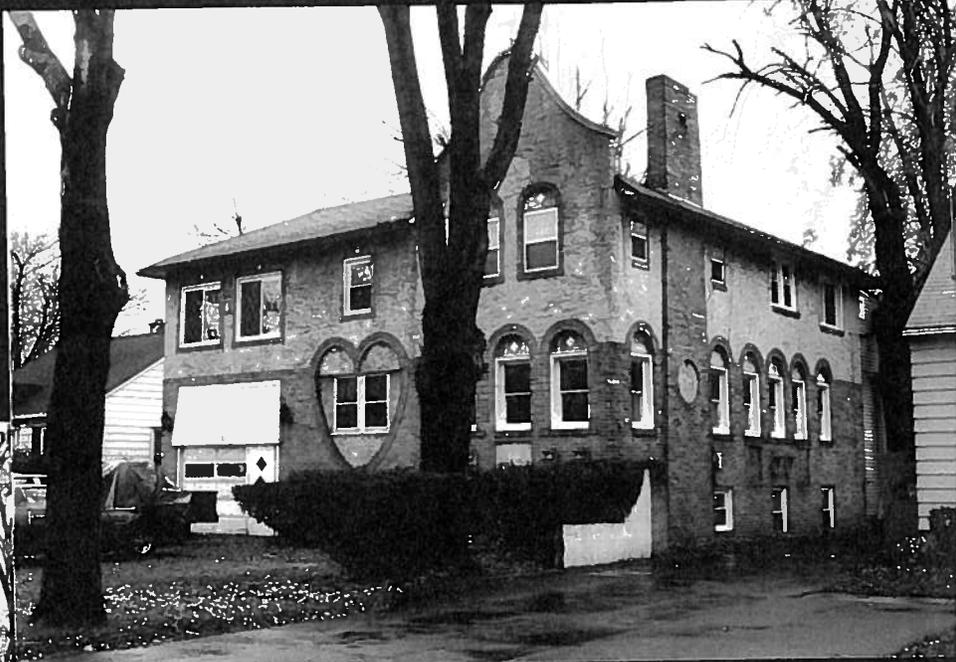
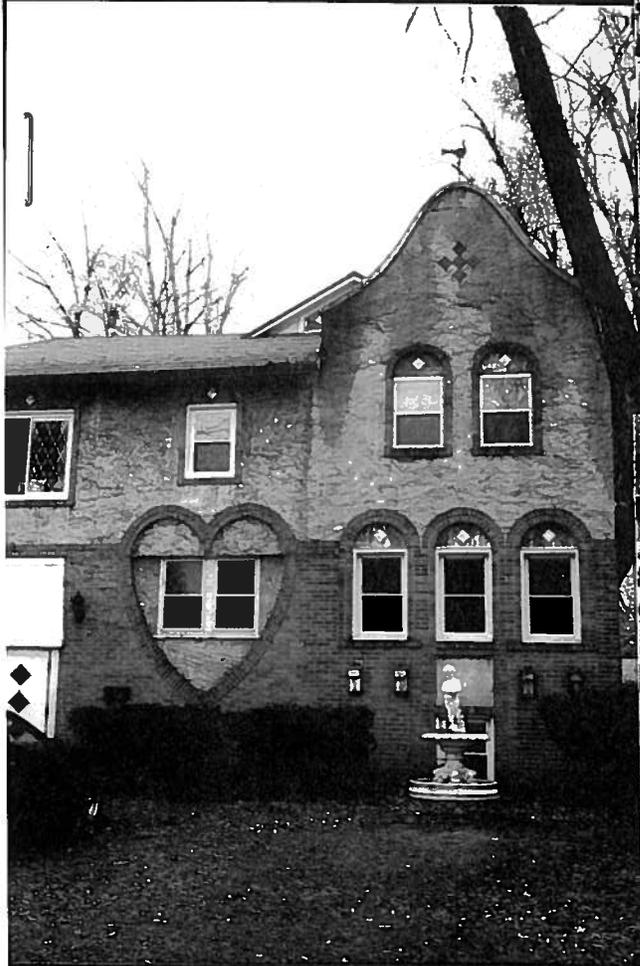
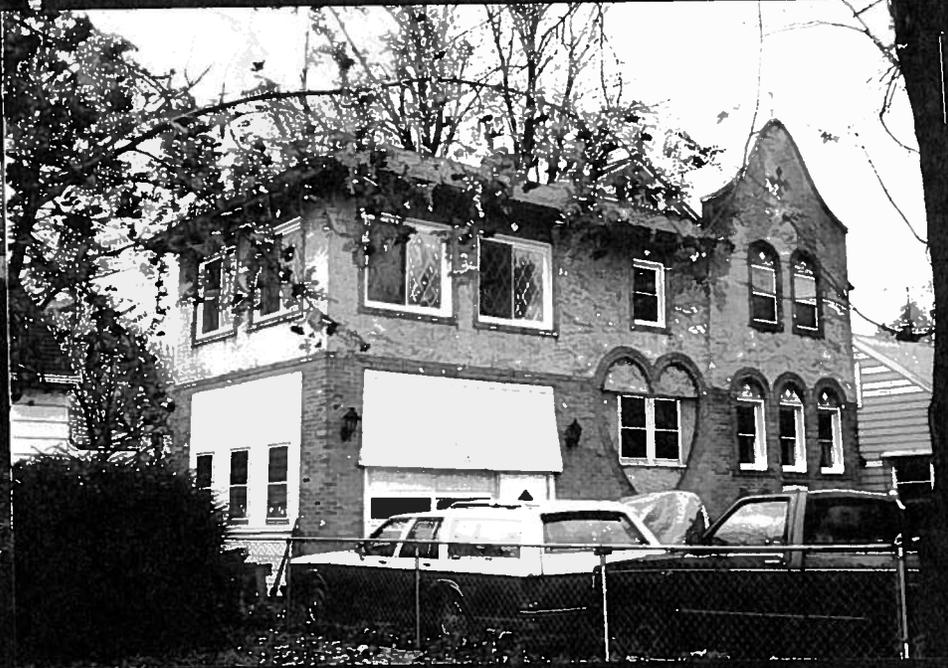
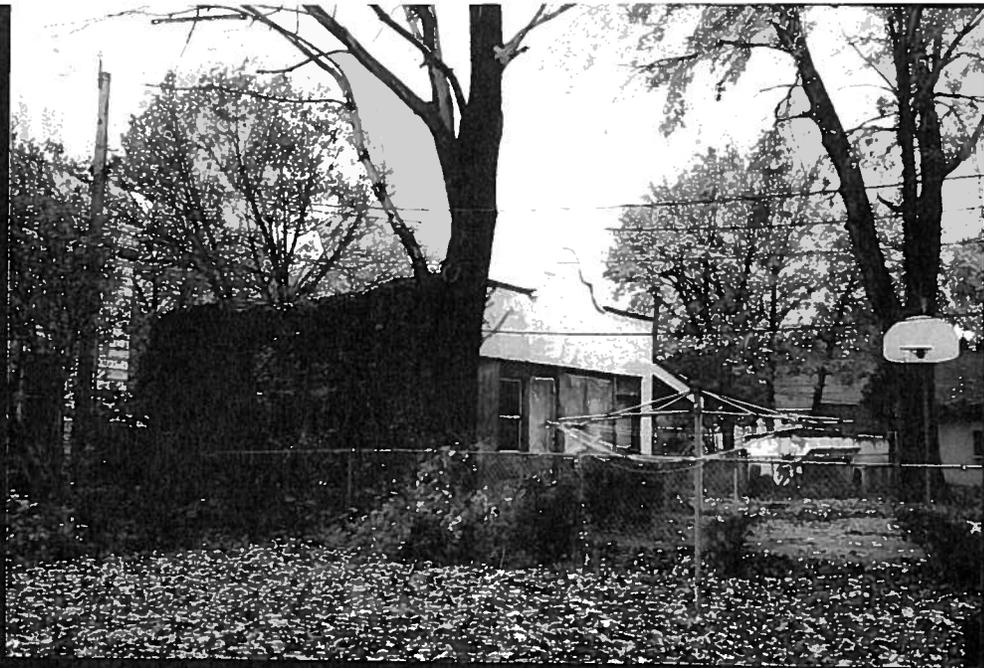
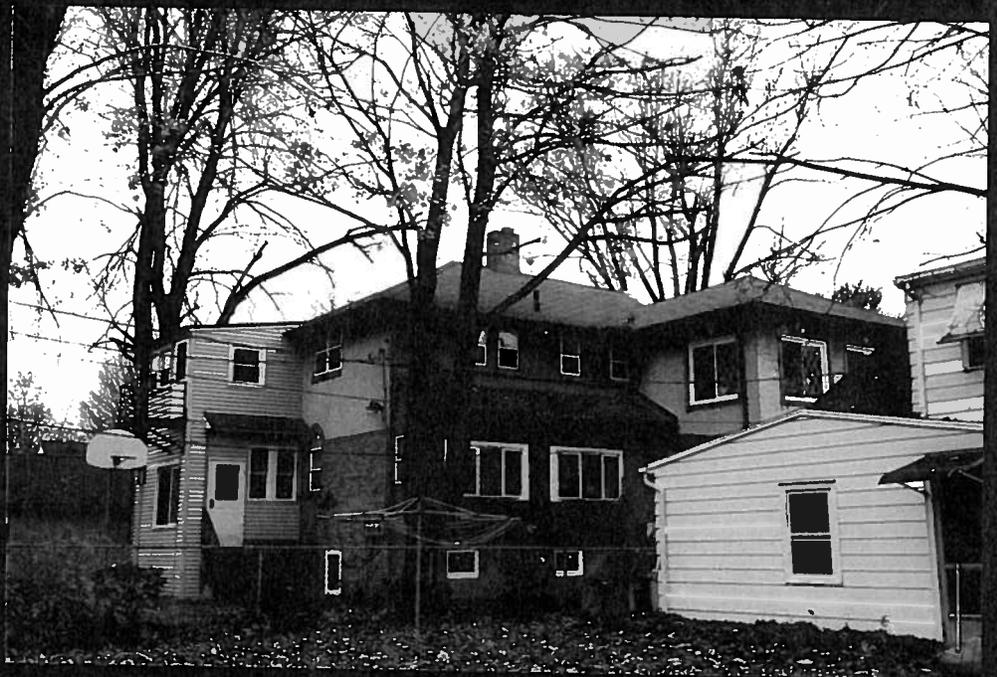
12. PHOTO:

18. A c. 1924-30, cross-gabled, two-story frame house with stucco and brick veneer. Fenestration is asymmetrical and consists of 1/1, double-hung windows with brick sills; two-sash, diamond-paned windows are located on the 2nd story over the original porte cochere. Decorative brick arches with stucco infill and a diamond-shaped, cream-colored ceramic tile top many of the exterior windows. On the first story of the north and west elevations, groupings of three and five contiguous arches/windows form an arcade.

The exterior is a veneer of brick on the first story; the second story and front parapet gable are stucco. A brick chimney with circular stucco panel is on the west side of the house and includes a decorative wrought iron tie rod. The facade features a number of distinctive details: the arched parapet gable with blue ceramic tile inset and wrought iron peacock finial, a small blue ceramic oval with cameo

figure located between the two diamond-paned windows on the second story and, its most prominent detail, the large heart-shaped panel bordered by two rows of bricks and finished with stucco infill. The north and west elevations also include three pairs of decorative cast concrete brackets (under 1st story windows).

The original open porte cochere (drive-through) at the northeast corner of the house has been converted into a garage. A modern garage door, entrance door, windows and synthetic siding have been installed here.

Projecting from the south (rear) of the main block is a two-story, synthetic-sided addition with fire escape. It has contemporary 1/1 windows, hinged exterior door and wood steps. This may date from the early 1940s, when the house was converted into two units: the owner's apartment and a rental unit.

The contributing garage at the rear of the property has a stucco veneer exterior and decorative arched parapet wall on the north elevation. The original garage door(s) have been removed and contemporary windows and door installed.
